## **APPENDIX D**

Distance-Drawdown Analyses Plots

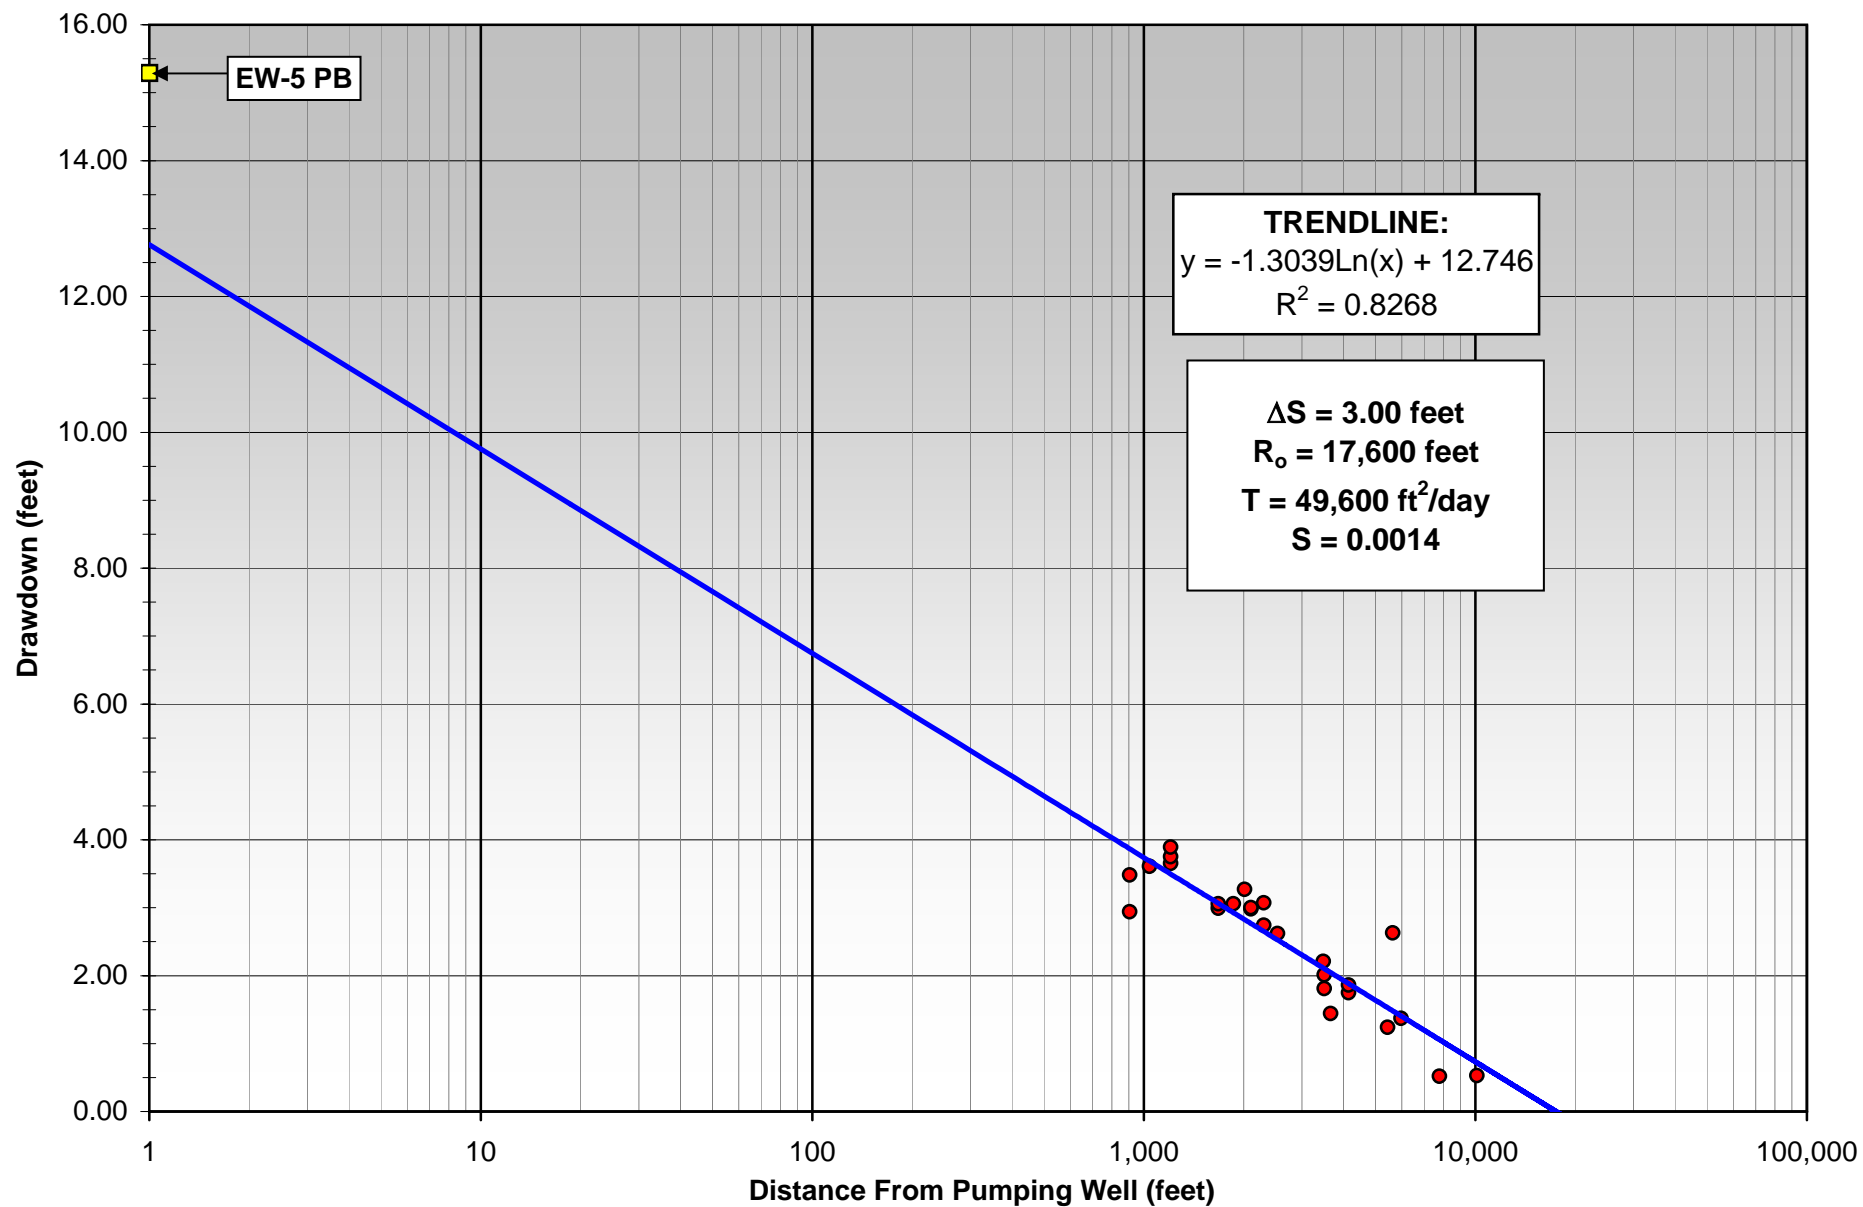
**Figure D-1**  
**Distance Versus *Trend-Corrected* Drawdown Response During the EW-5 Pumping Test**  
**Observation Wells Screened Within the LWBM**  
Newmark Groundwater Contamination Superfund Site

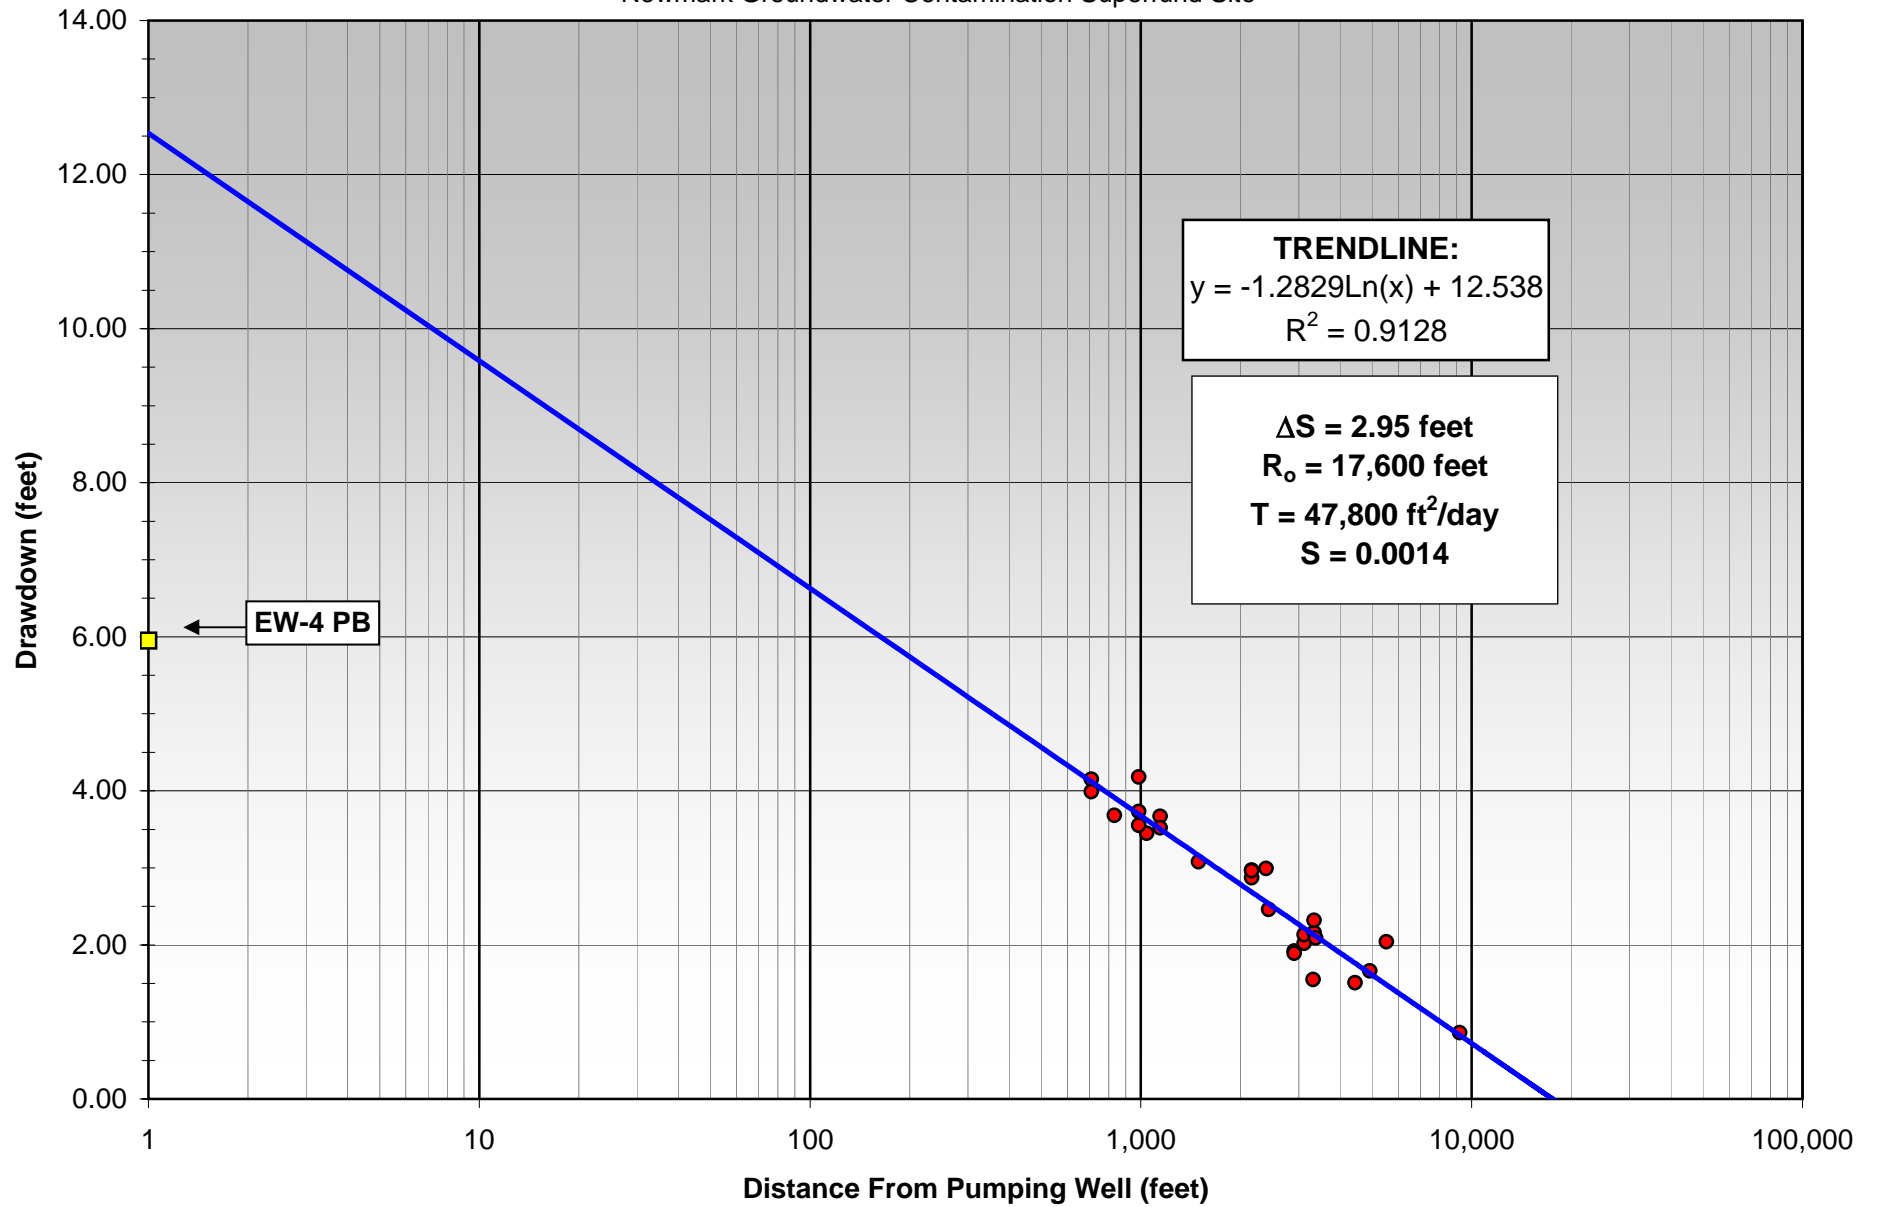
**Figure D-2**  
**Distance Versus *Trend-Corrected* Drawdown Response During the EW-4 Pumping Test**  
**Observation Wells Screened Within the LWB**  
Newmark Groundwater Contamination Superfund Site

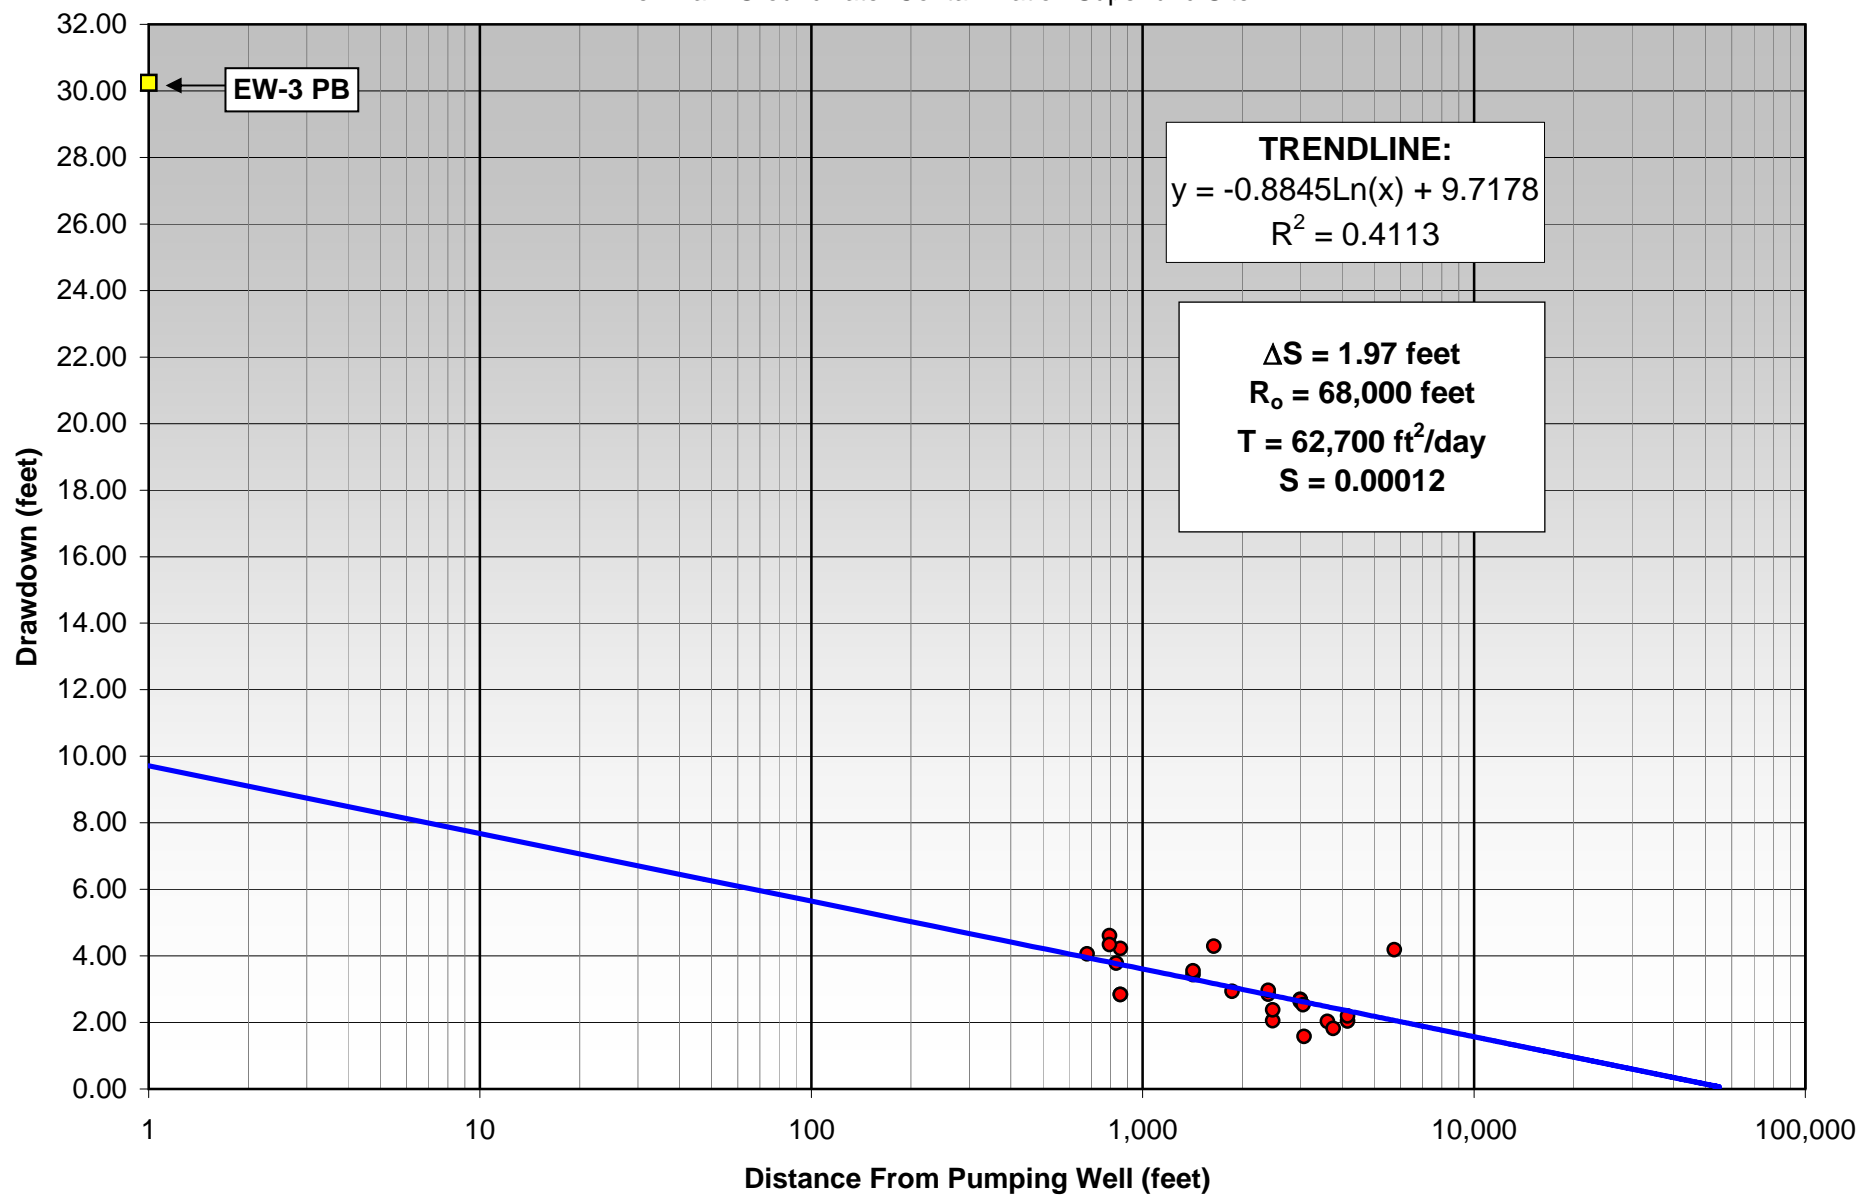
**Figure D-3**  
**Distance Versus *Uncorrected* Drawdown Response During the EW-3 Pumping Test**  
**Observation Wells Screened Within the LWBM**  
Newmark Groundwater Contamination Superfund Site

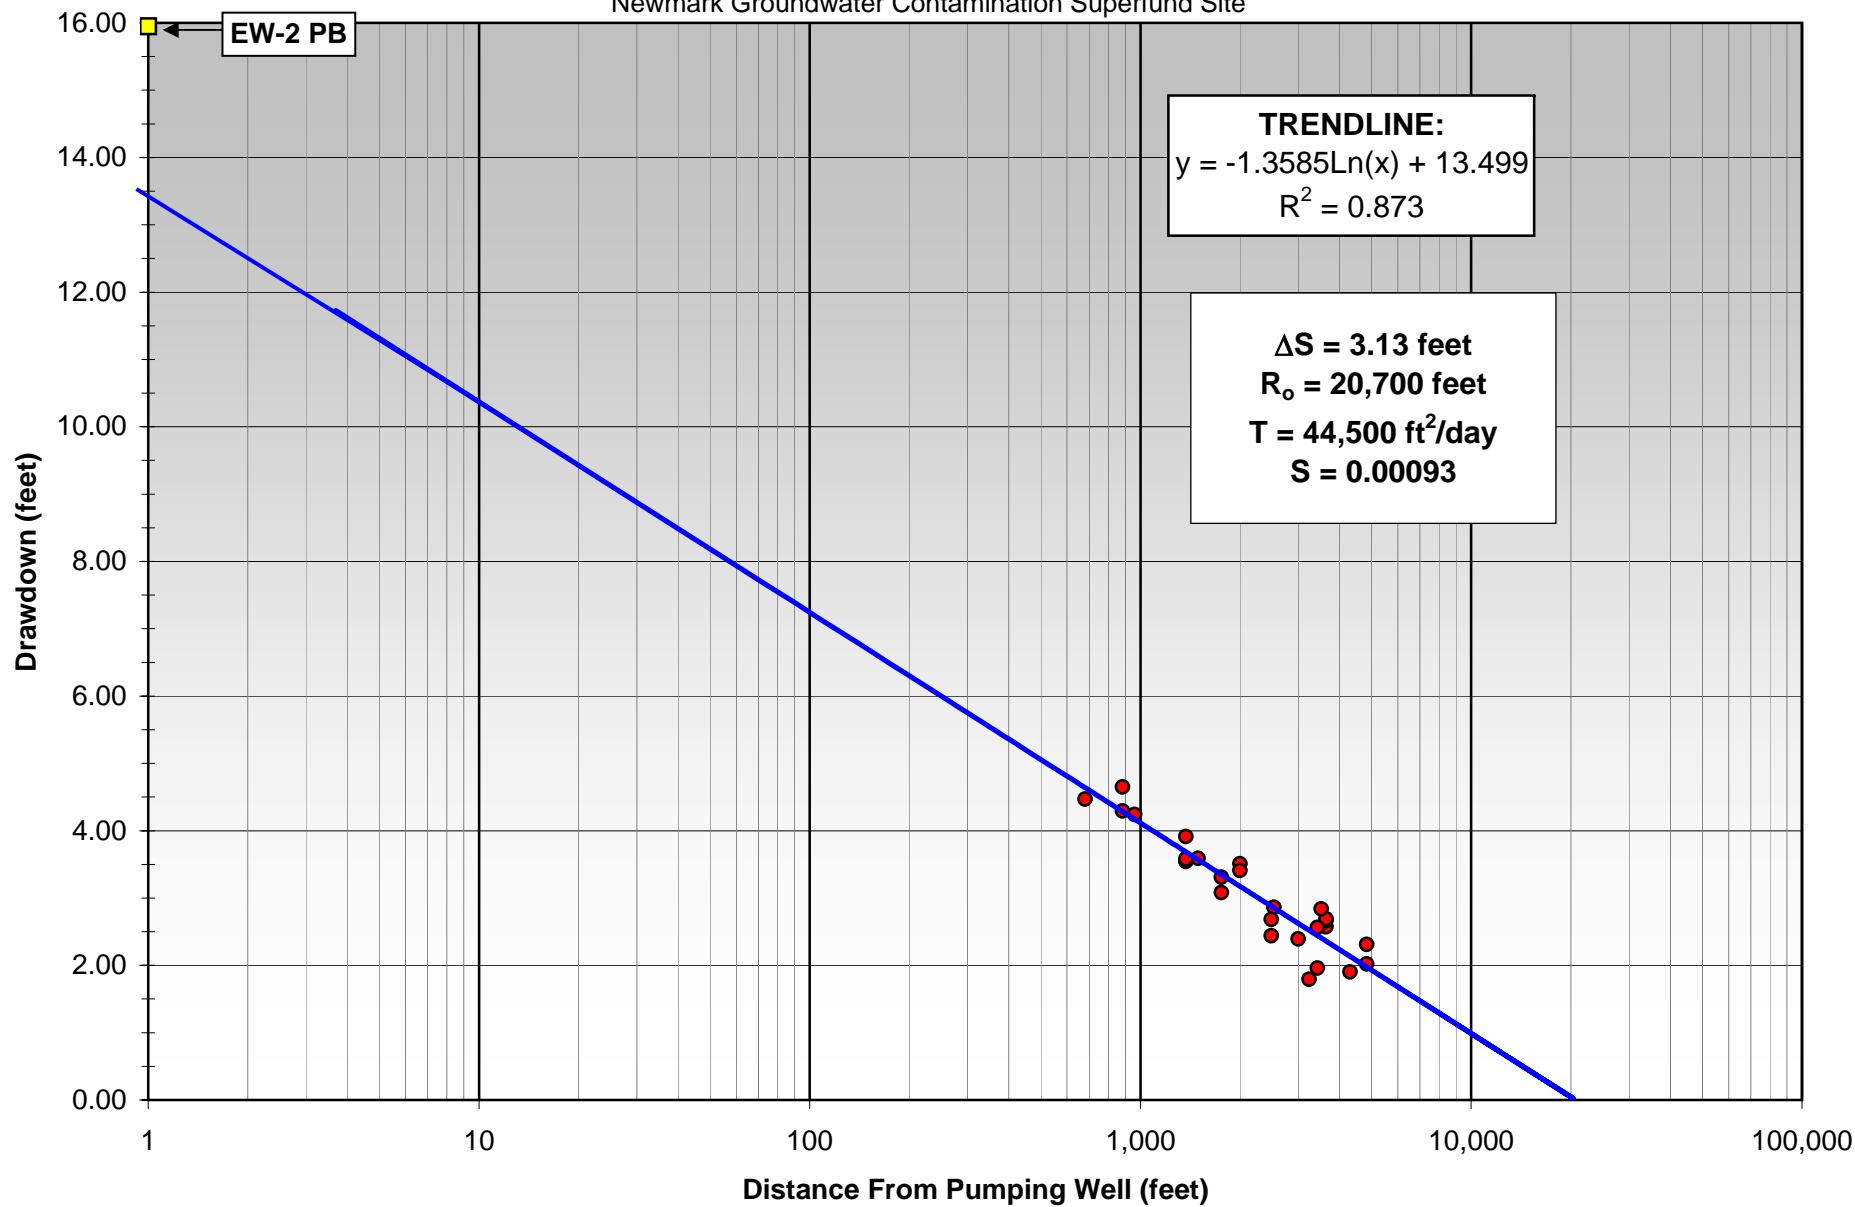
**Figure D-4**  
**Distance Versus *Trend-Corrected* Drawdown Response During the EW-2 Pumping Test**  
**Observation Wells Screened Within the LWBM**  
Newmark Groundwater Contamination Superfund Site

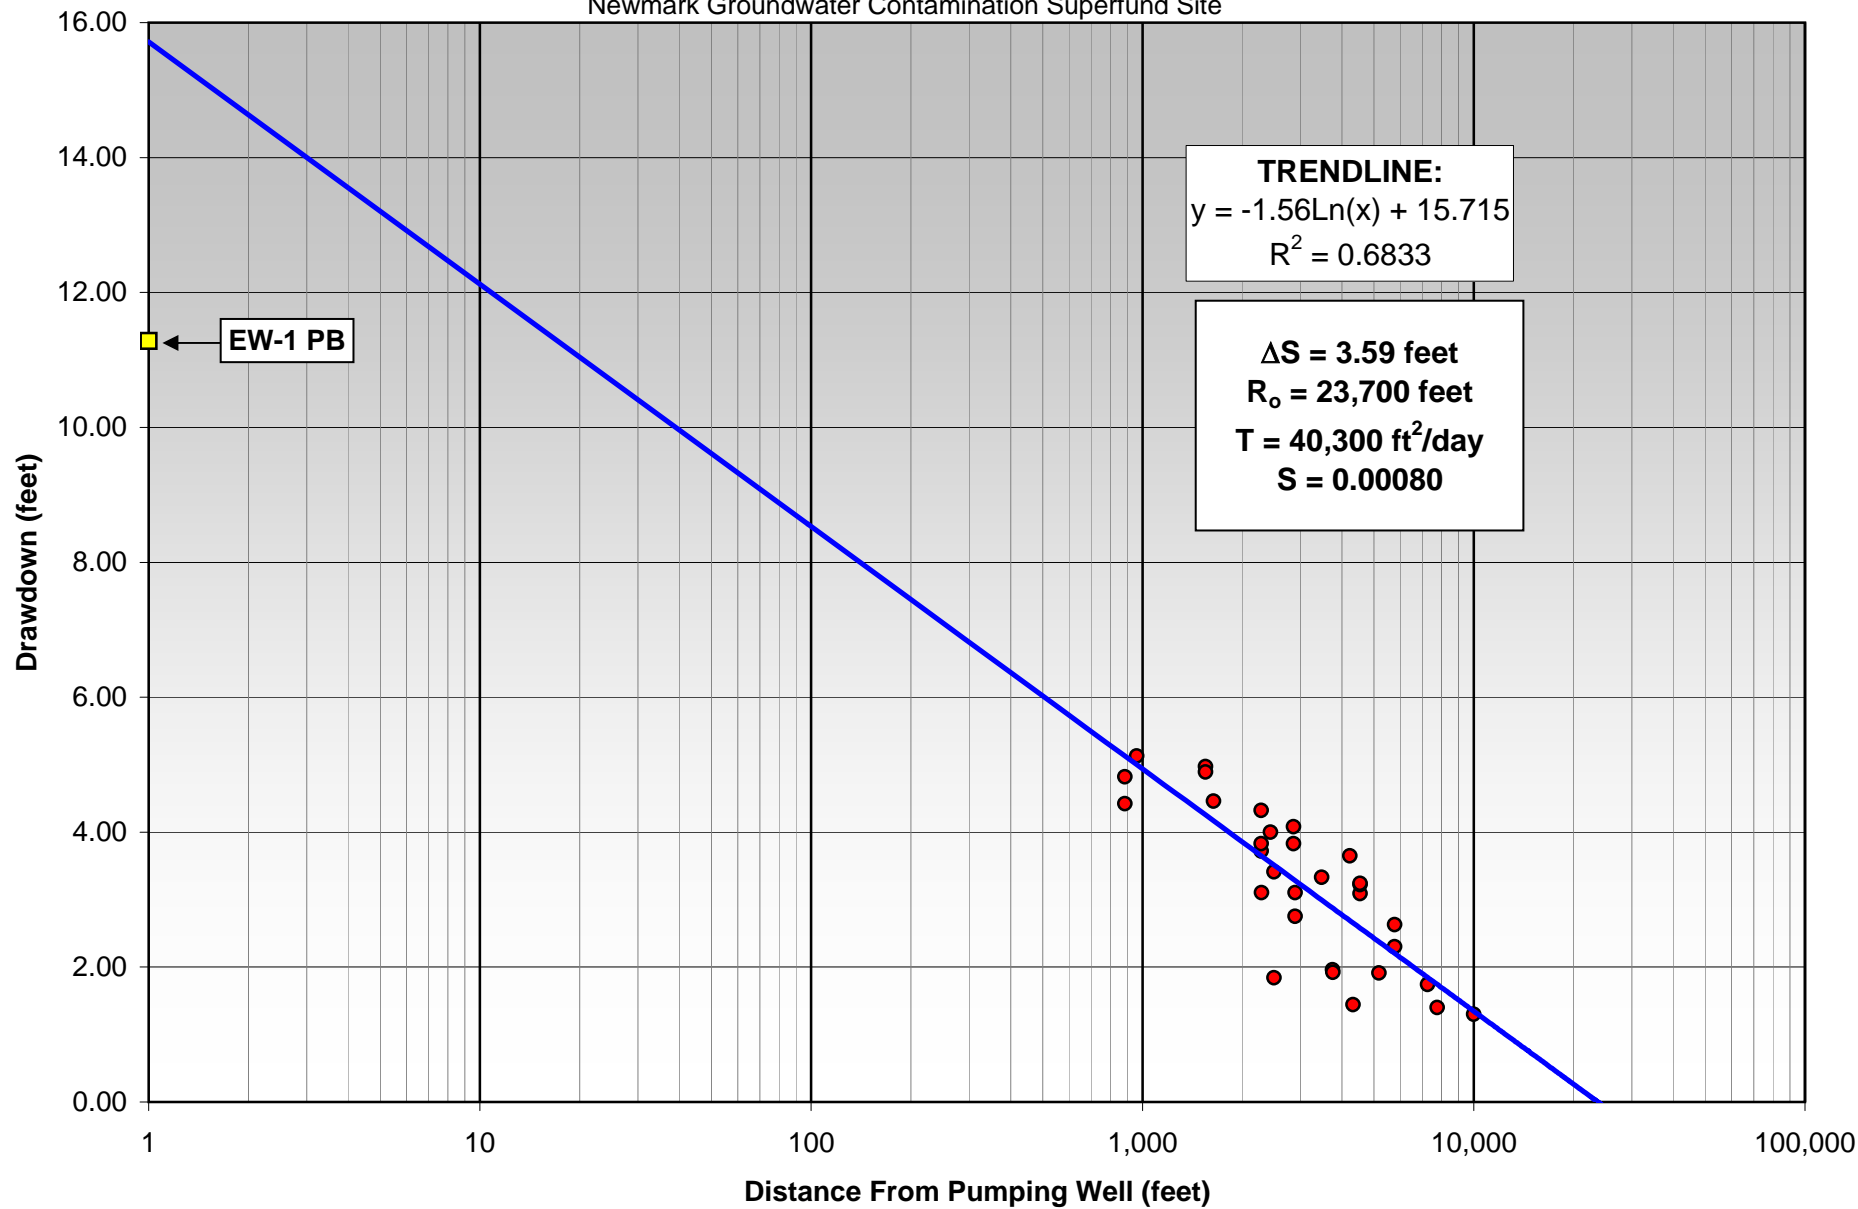
**Figure D-5**  
**Distance Versus *Uncorrected* Drawdown Response During the EW-1 Pumping Test**  
**Observation Wells Screened Within the LWBM**  
Newmark Groundwater Contamination Superfund Site

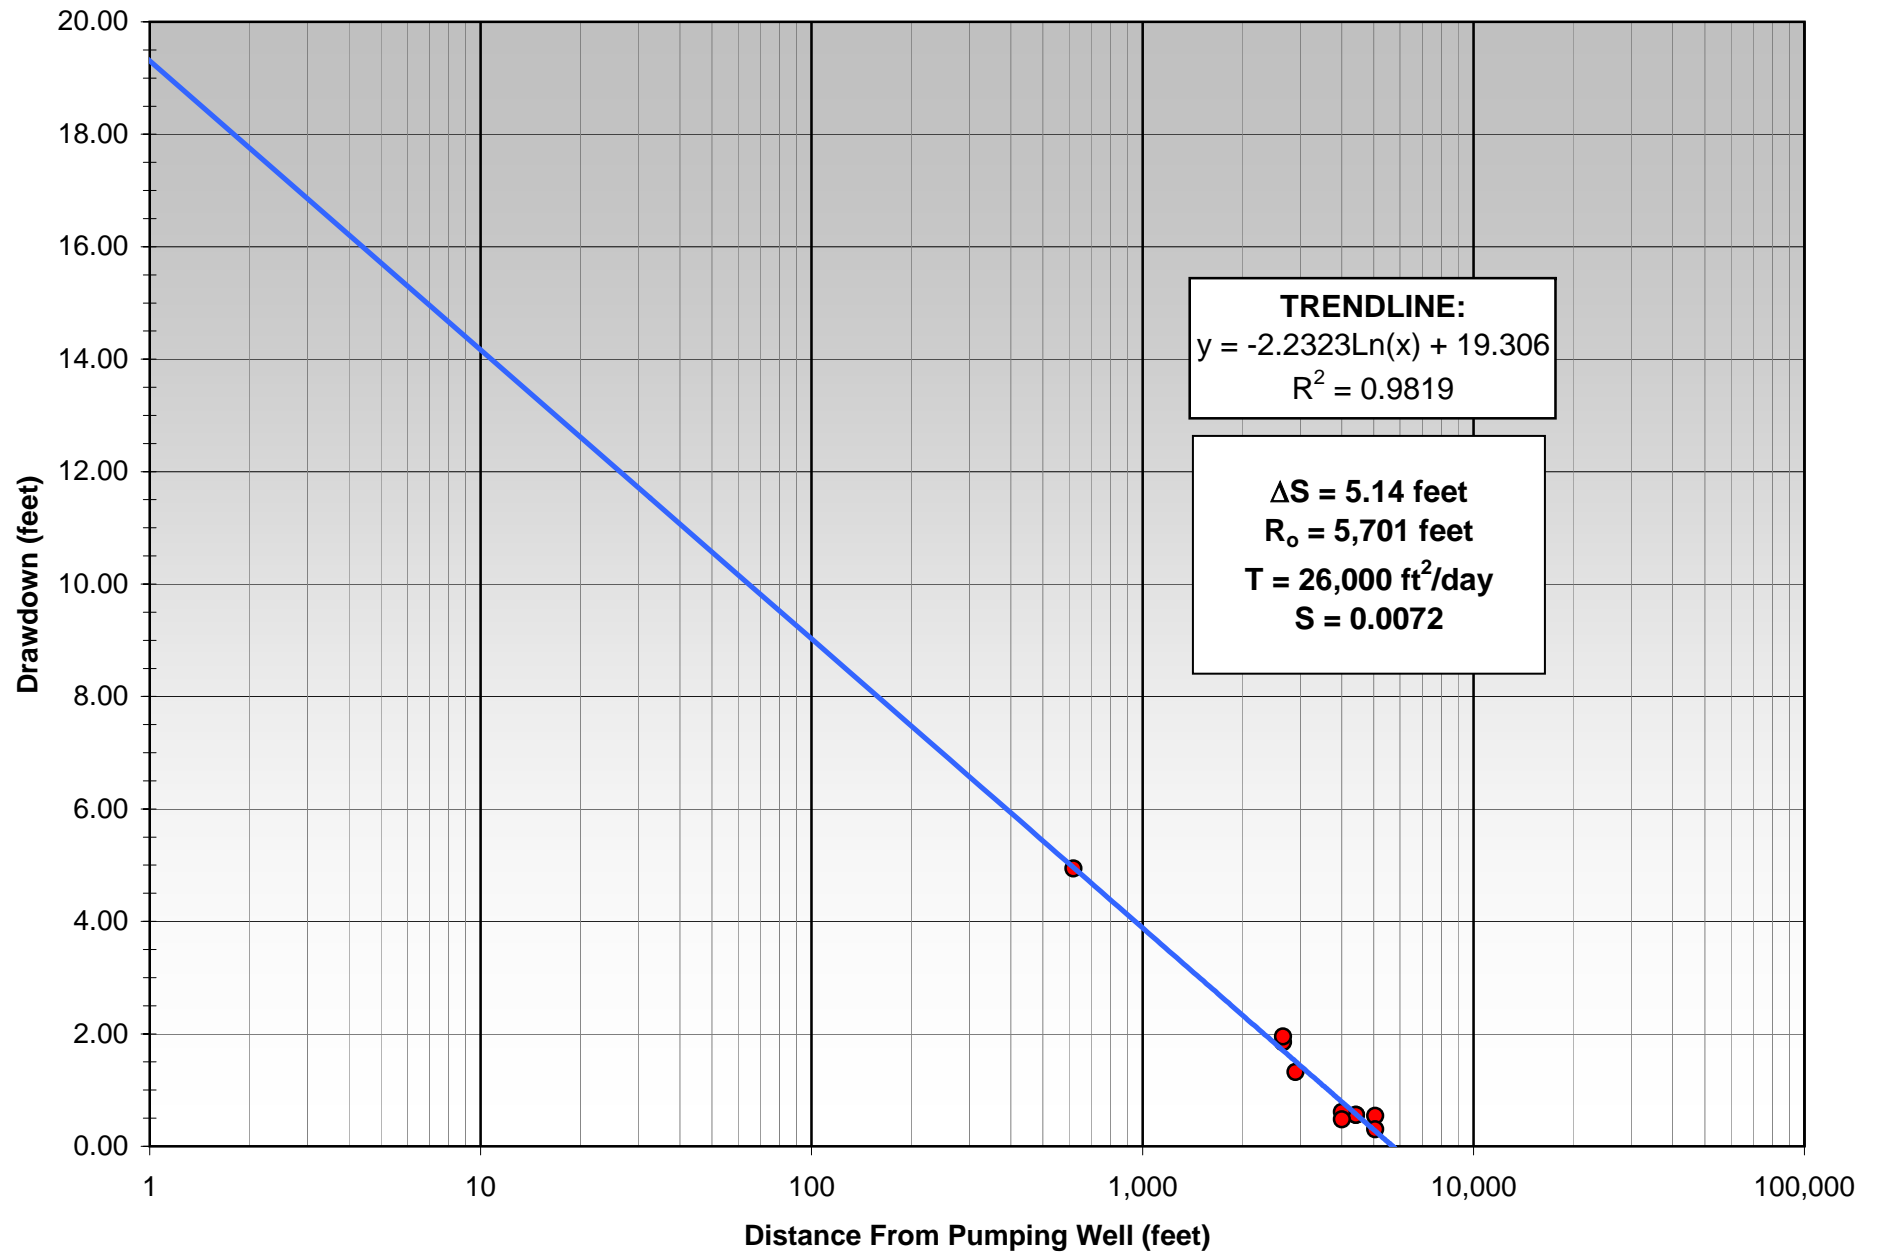
**Figure D-6**  
**Distance Versus *Uncorrected* Drawdown Response During the WD#15 Pumping Test**  
Newmark Groundwater Contamination Superfund Site
